# The Jurassic coast

## Mass movement processes

Alan Holiday

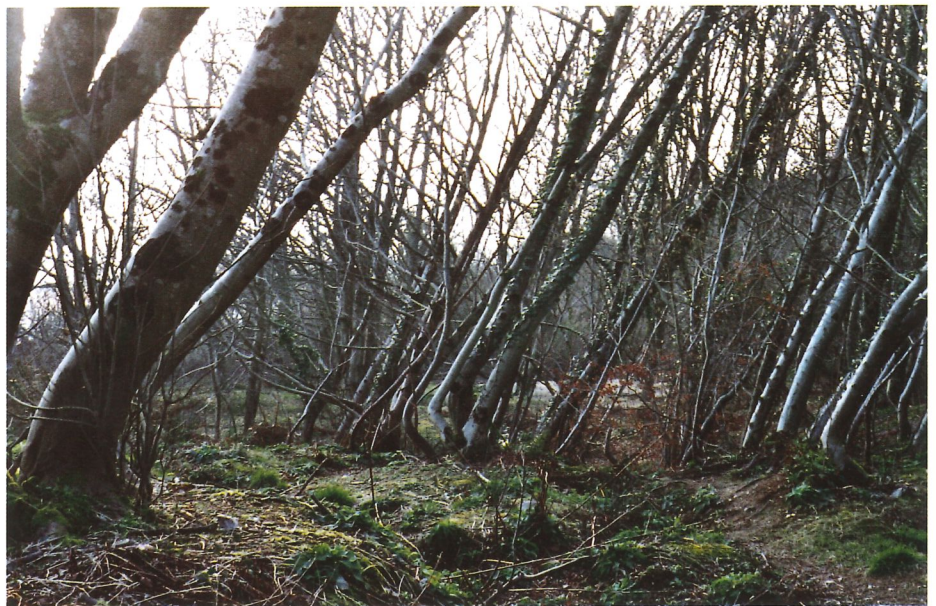
(A) Trees deformed by movement on the Spittles landslip area, Lyme Regis

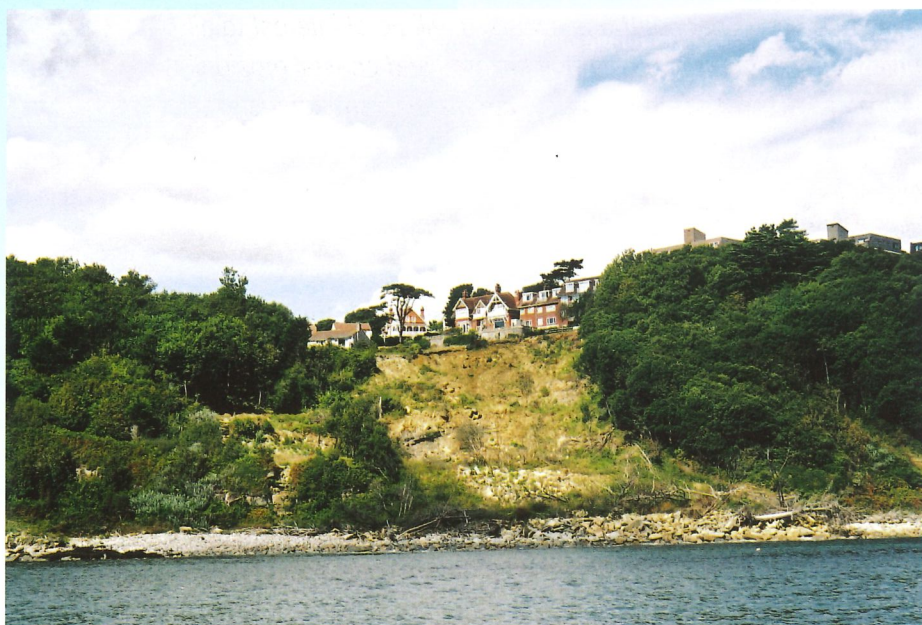
(B) Durlston Bay landslip seen from the sea

What causes mass movement? We have already identified gravity and water as important. Other factors include lithology (rock type), the relationship between different beds of rock (permeable and impermeable), other rock features, especially jointing (fractures in the rock), and a space into which the rock material can move. As water is a factor in the process, weather and climate are important. In the wet winter of 2000–2001 there were major events on the Jurassic coast at Worbarrow Bay, Black Ven and Stonebarrow and a landslide event in Durlston Bay. This last event had a major impact on property (photograph B).

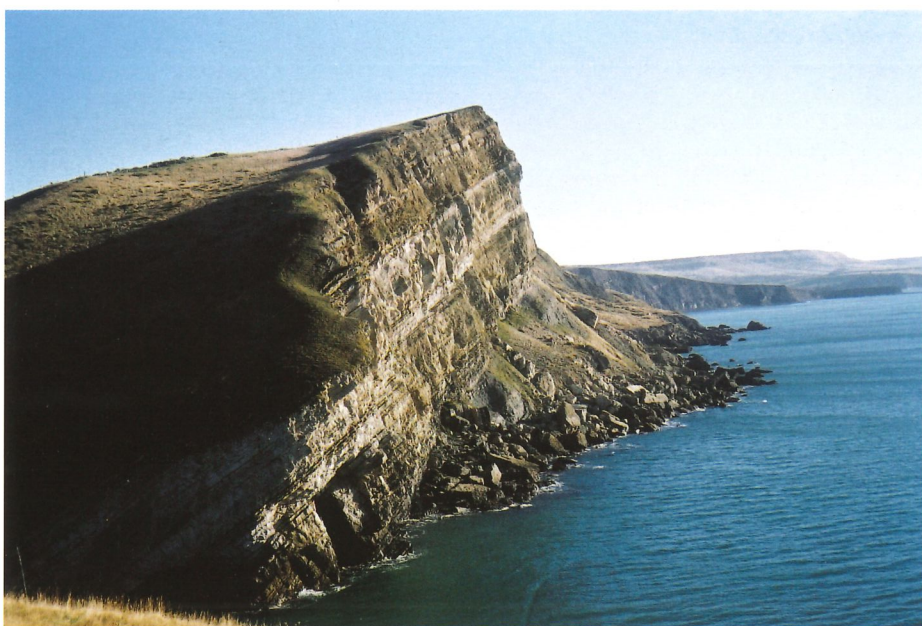
(C) Gad Cliff strata dipping landward (north)

further movement. The dip of the strata (rock layers) is also important. Rocks that dip inland form more resistant coastlines — if the dip is seaward rock slides are more likely to occur. The coastline at Worbarrow Tout and Gad Cliff between Lulworth and Kimmeridge provides good examples of this (photograph C).

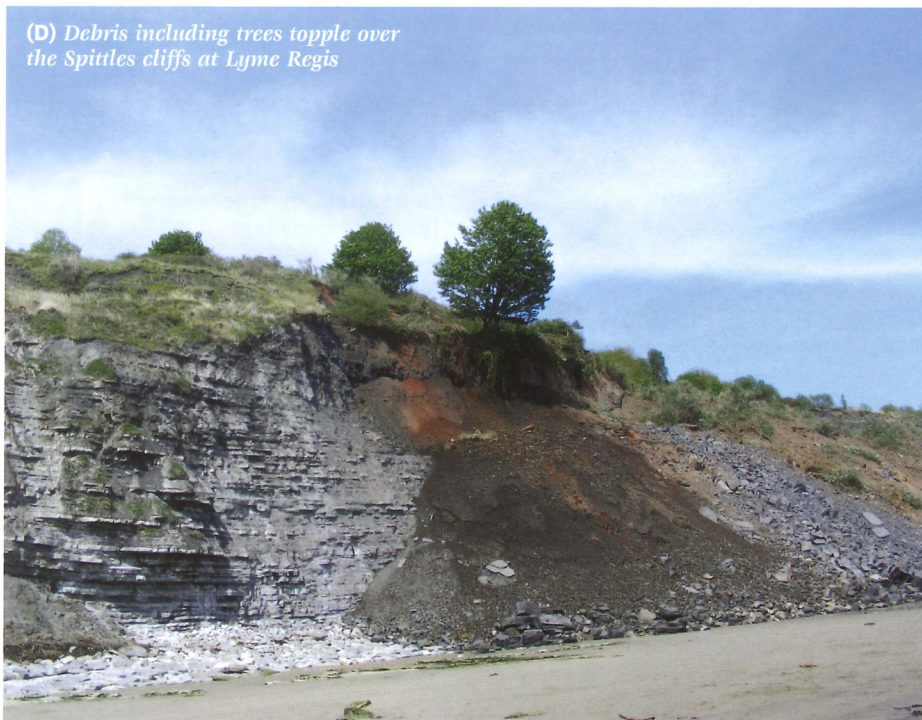
(D) Debris including trees topple over the Spittles cliffs at Lyme Regis

The cliff falls at Lyme Regis in 2008 made the national news. On 6 May a major fall some 300 metres long occurred to the east of Lyme Regis (the Spittles). Fortunately it occurred at 8.30 p.m. when the tide was in and the area was inaccessible to the public. If it had happened a day earlier in the middle of the day (Bank Holiday and low tide) there could have been catastrophic loss of life, although there might have been some warning signs that the event was going to happen. This area is popular with families on holiday and with fossil collectors. After the initial event, material continued to cascade over the Spittles cliffs, including mature trees (photograph D).

stone (Cretaceous Upper Greensand) resting on impermeable clays (Jurassic Blue Lias – the lower part of the cliff in photograph D), shales with beef, the Black Ven marl and Belemnite marls). Beds of limestone form terraces in the cliff and beds of shale just above provide the slip surfaces.

The May 2008 event just affected the shales with beef (the upper part of the cliff in photograph D). Following the event people were kept away by the coastguard and a British Geological Survey team was brought in to survey the cliff movements.

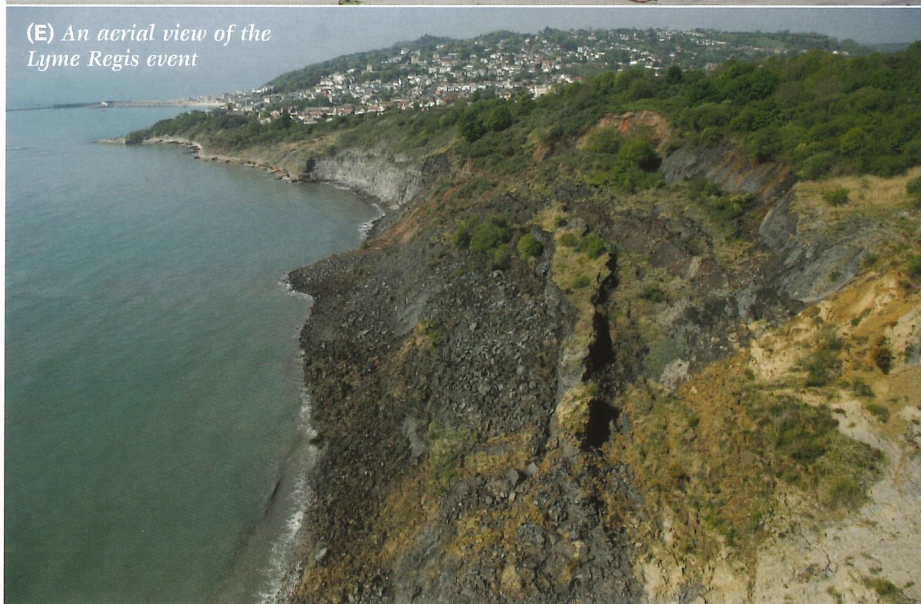
(E) An aerial view of the Lyme Regis event

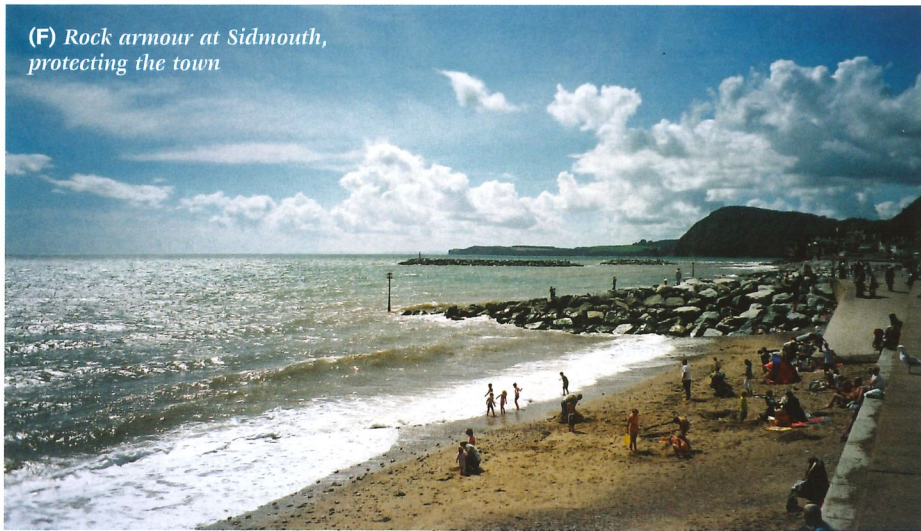
(F) Rock armour at Sidmouth, protecting the town

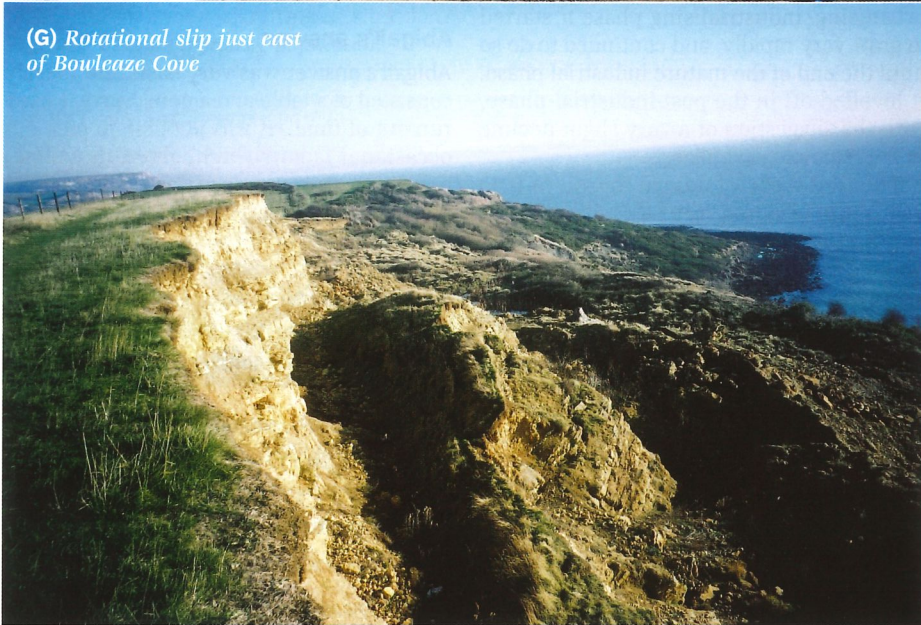
(G) Rotational slip just east of Bowleaze Cove

A groyne was built at the Weymouth end of the beach but not at the Preston end so there is an ongoing problem. Not so lucky are those properties on the north side of Portland Harbour, which have been identified as likely to be lost through mass-movement over the coming decades. The geology in both these cases is similar, with Corallian limestone and sandstone inter-bedded with clay resulting in rotational slip (photograph G).
